Communication Losses between PeakSimple and GC November 2014

Communication between the GC and computer via USB cable is sometimes temporarily lost (disconnects).

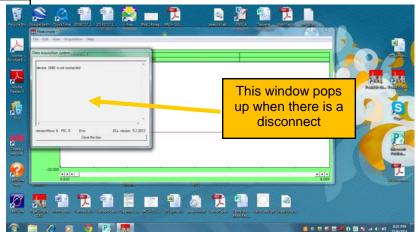
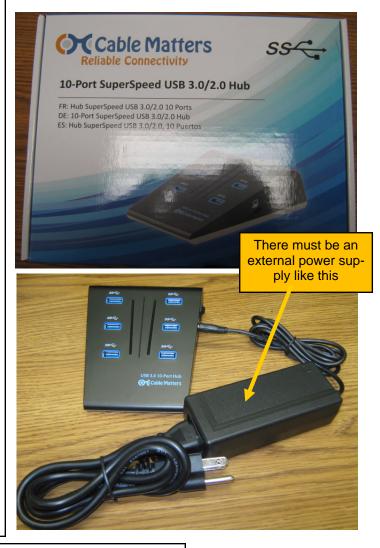
SRI has determined that disconnects are sometimes caused when the +5volt power supply of the computer is intermittent. Some computers do this frequently, some never. This is important because the USB cable is powered from the computer's (not the GC's) 5volt supply.

To prevent this from happening, purchase a product called a "powered USB hub" like the one at right which we bought from Amazon for about \$30 in November 2014.

- 1) There must be an external power supply, and
- 2) Try to get USB 3.0 rather than USB 2.0 compliance

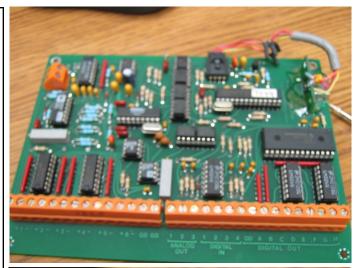
We have also made a firmware update in November 2014 which substantially eliminates disconnects on the 302 six channel A/D board.

Gently pry the chip out of the socket with a small screwdriver.
