Micro-controller replacement in the SRI Model 333 Data System

With the advent of the Windows7-64bit operating system in December 2009 it was found that the firmware in the Cypress microcontroller in the SRI Model 333 A/D board needed to be updated in order to function with the 64bit version of Windows&7 (also 64bit Vista).

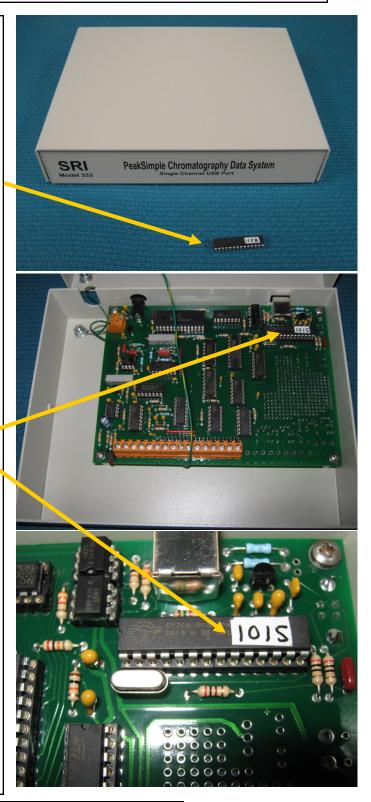
Locate the micro-controller on the circuit board. The chip has the USB device ID number written on it.

The replacement chip will have a different number printed on it.

The upgraded micro-controller is SRI part# 8600-1052 price: US\$ 138.00 (2022 pricing, prices subject to change, consult most recent price list.)

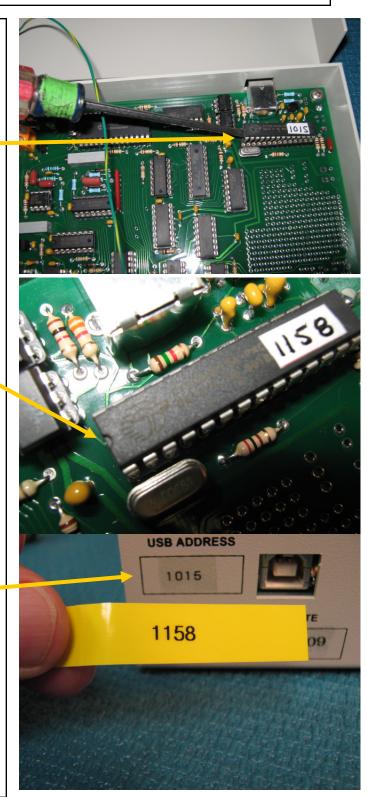
Notice that the chip has a little half circle on one end.

This end should be oriented to the left when the new chip is installed.

Use a small blade screwdriver to lift (wiggle) the chip out of its socket. Insert the screwdriver tip between the chip and the socket and gently lift. Try not to bend the pins.

Wiggle/press the new chip into the socket being careful not to bend any of the pins.

Finally make a label with the new chip's device id# and attach it to the back of the chassis.

You will have to enter this number in the PeakSimple software's Edit/ Overall screen.

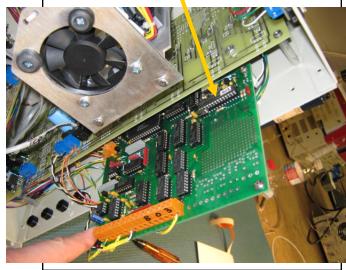
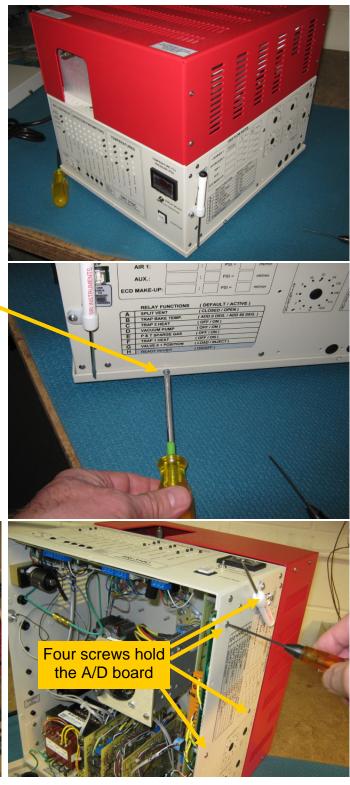
If your Model 333 data system is installed in an SRI GC then you will need to gain access to the A/D board to replace the microcontroller chip.

Unplug the GC's power cord.

Remove the six screws holding the bottom cover on the GC. Then tilt the GC up on its back so you can see inside.

Use a 5/64th hex wrench to remove the four screws holding the A/D board in the GC.

Slide the A/D board out halfway so you can access the microcontroller chip. Replace the chip as described.
