# FID Noise Troubleshooting

## August 2026

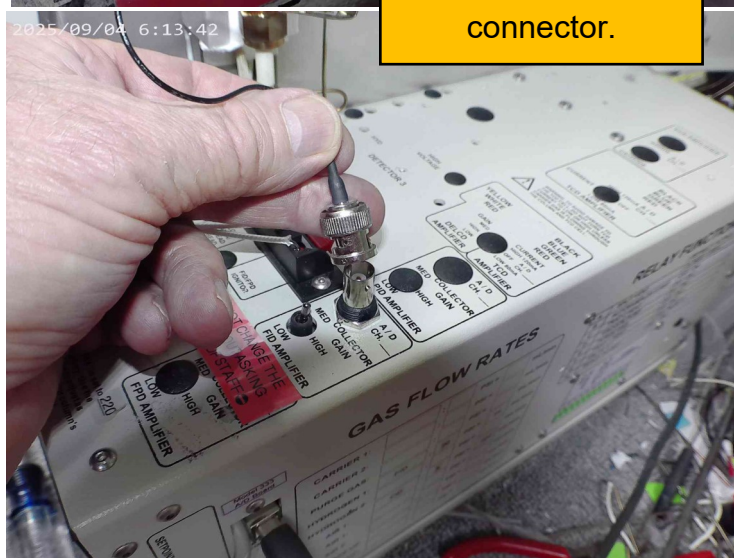
Remove the BNC connector by twisting and lifting.

Remove the BNC connector.

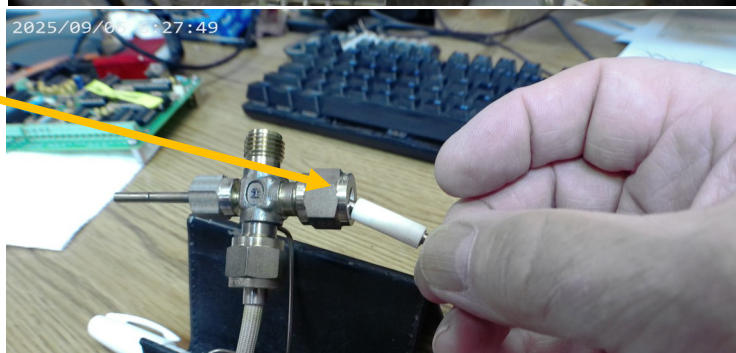
If the noise is significantly worse than in Step 1, then its likely the FID collector electrode's white ceramic insulator is dirty and allowing some leakage current to flow. The collector electrode looks like this.

Remove it by loosening the 1/4" swagelok nut which holds it. It is sometimes easier to remove when its hot so use a pliers to grab it instead of your fingers.

When re-installing the cleaned collector electrode push it in toward the flame jet until it hits a mechanical stop, then pull about 1mm ( not critical ) to the right so the collector is not actually touching the stop. GCs built before 2005 may not have the mechanical stop.

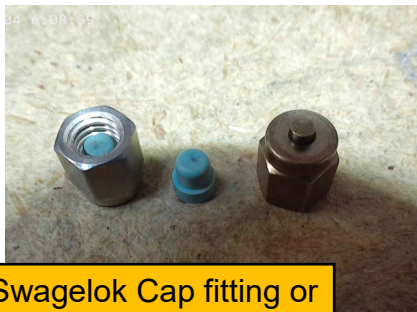
Plug the FID inlet fitting with a swagelok cap fitting or a swagelok nut with a septum inserted in the nut ( note the orientation of the septum– the fat end goes into the nut first ).

Swagelok Cap fitting or nut with septum to block off FID inlet.
