# AFP valve board replacement

Sometimes it may be necessary to replace the circuit board which controls the AFP valve actuator. AFP calls this actuator a MEA ( micro electronic actuator ). There may be one, two or three MEAs inside an SRI GC. The MEAs are located here inside the GC.

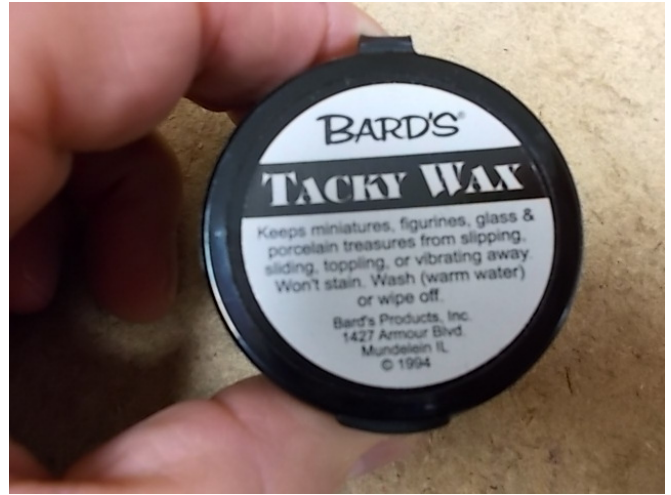
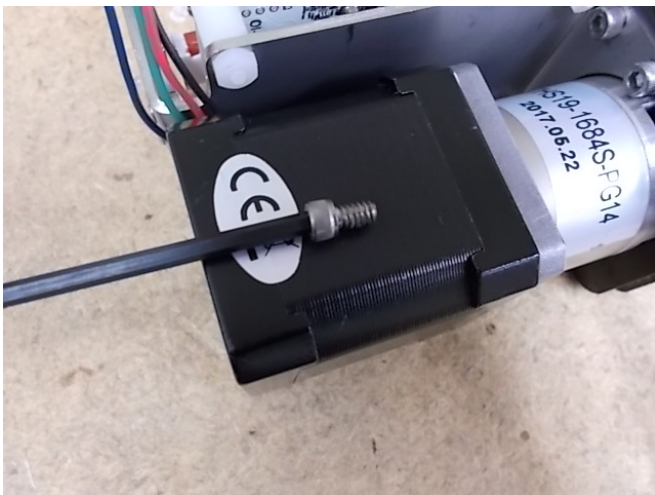
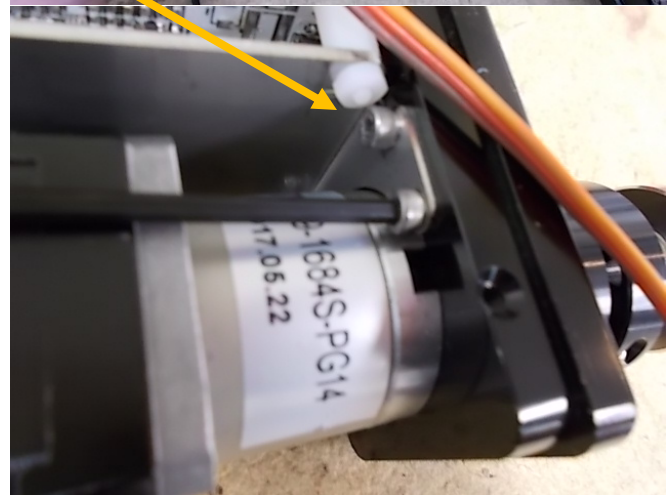
Tacky Wax is helpful because it keeps the screws from falling out of the wrench when you remove the 4 hex head screws which hold the circuit board in the MEA. SRI will normally include a little bit of the TackyWax in a plastic bag when we send a replacement board.

Smear a little TackyWax on the end of the wrench before inserting the wrench in the hex head screw so it does not fall out inside the GC.

There are four screws which hold the circuit board

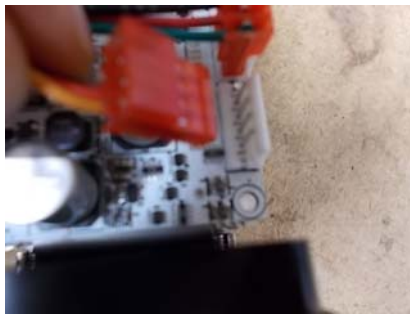
This connector has Red, brown and orange wires. These wires are the control wires which move the MEA from Load to Inject.

The connector has 4 positions but the mating jack may have 6 pins. If the leftmost and rightmost pins have not been removed, be sure to re-install the connector to the middle 4 pins.
