Replacing the TID bead on SRI 8610C and 310C GCs

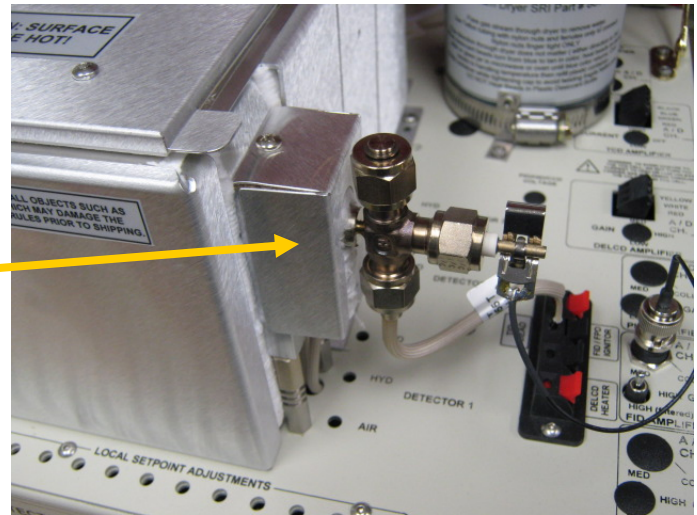
The TID detector is mounted on the right side of the GC's column oven.

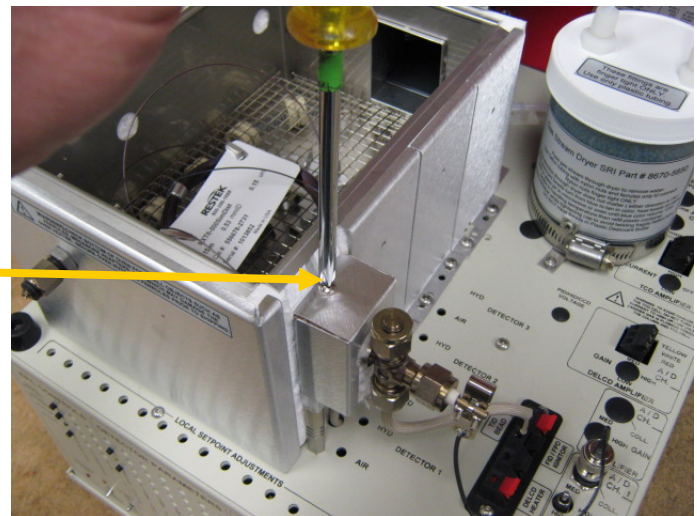
Use a phillip head screwdriver to remove the screw holding the insulation cover.

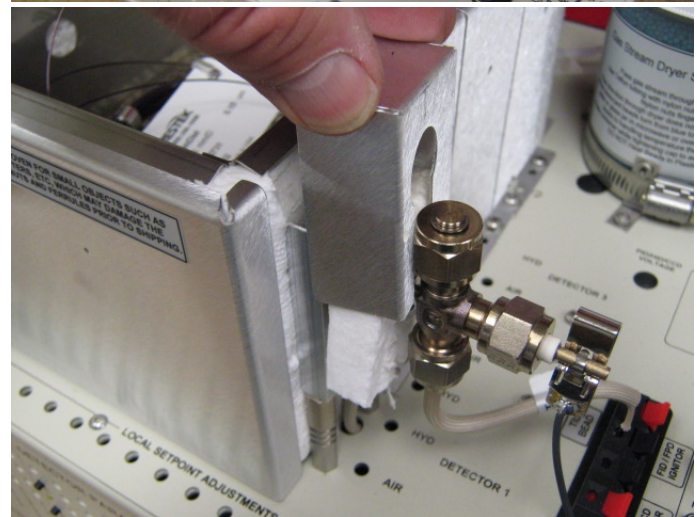
Remove the aluminum cover. Be sure the detector is cool before touching.

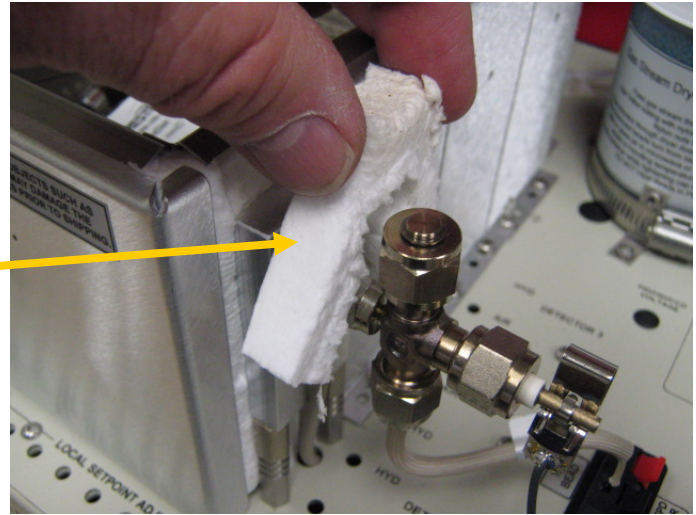
Remove the insulation carefully to avoid breaking off any.

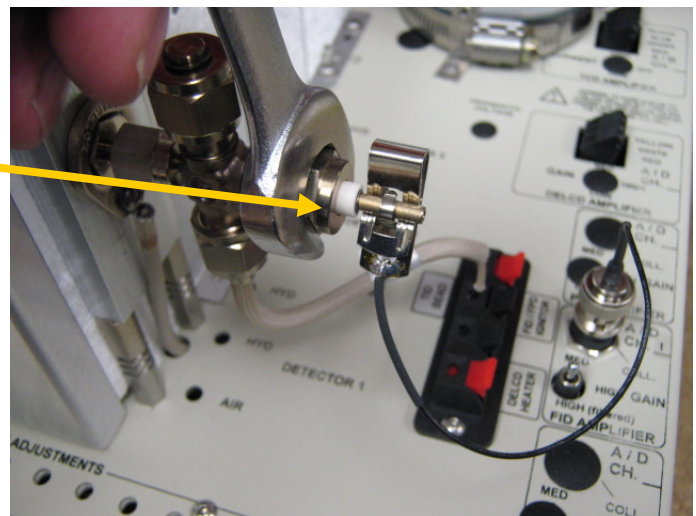
Use a 9/16" wrench to remove the collector electrode. Note how far the white alumina insulation protrudes from the back of the nut.

It's a good idea to make a magic marker line on the alumina before removing.

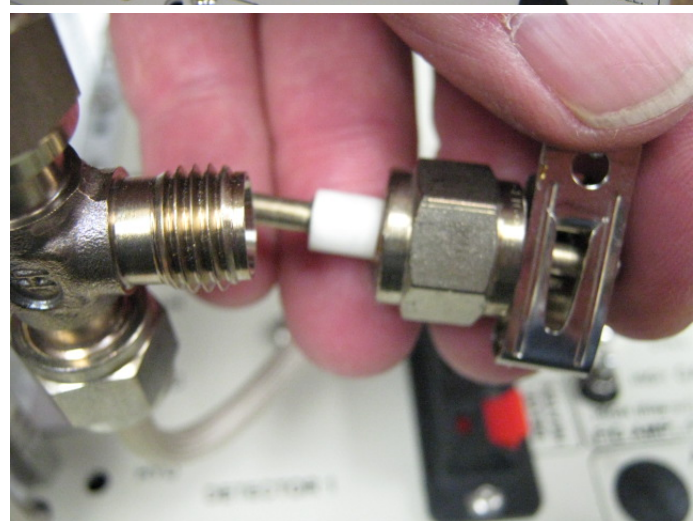
Remove the collector electrode from the detector.

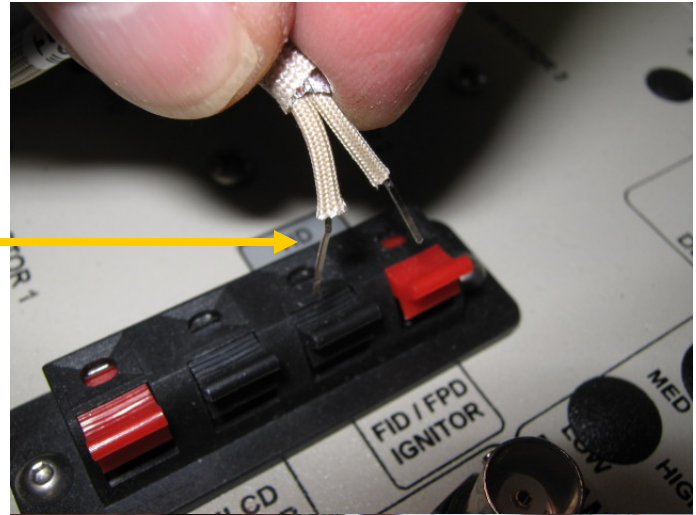
Unplug the TID from the push terminals.

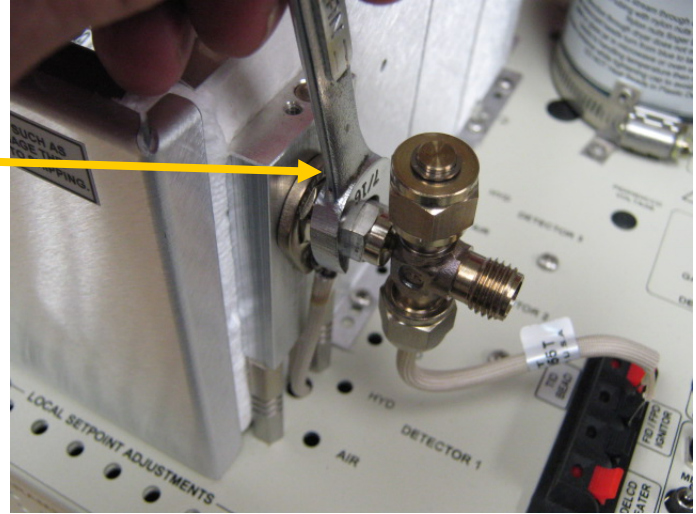
Use a 7/16" wrench to loosen the detector body from the bulkhead fitting.

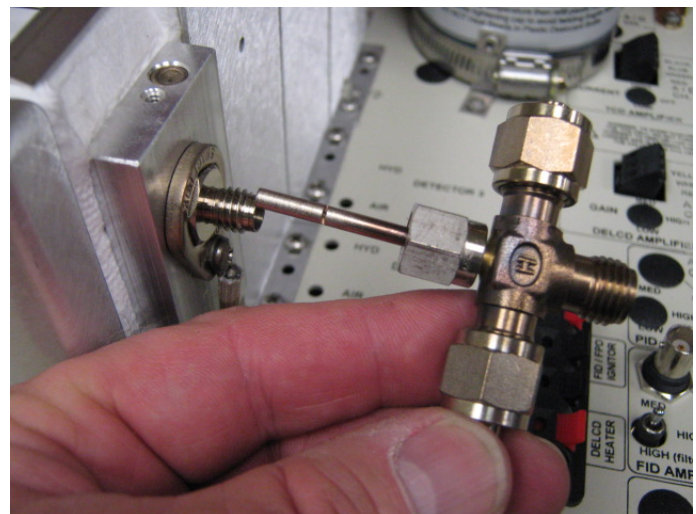
Slide the detector body out of the bulkhead fitting.

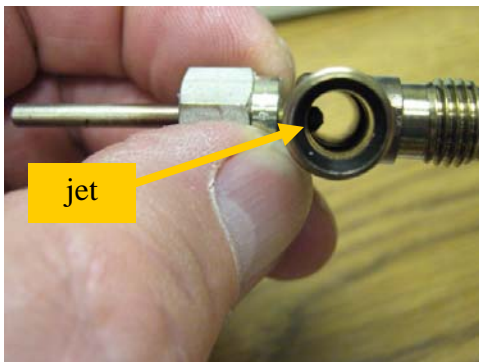
Remove the detector cap so you can see better inside the detector body.

When you look inside the detector body you will see the bead positioned directly in front of the jet.

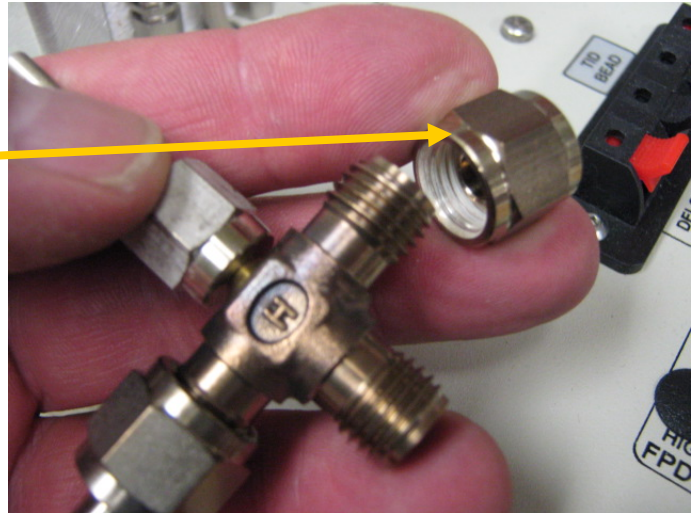
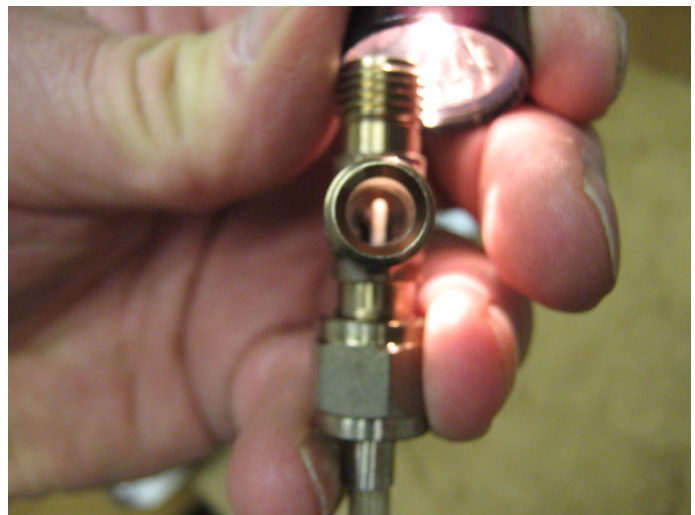
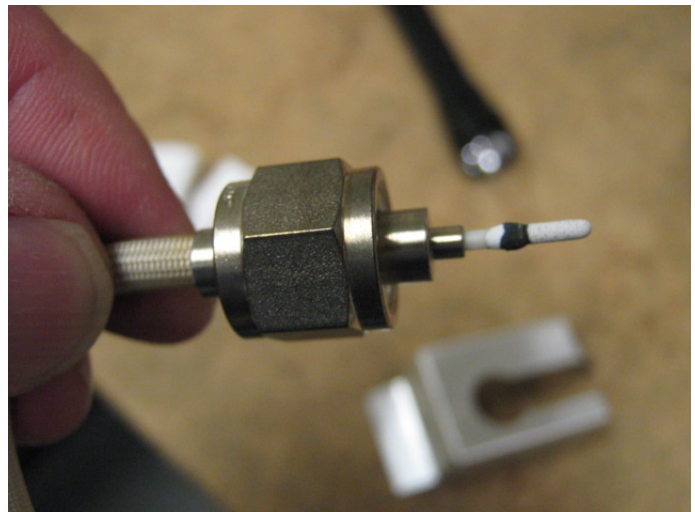
Remove the old bead carefully. It is a ceramic, so it can break if bent or banged.

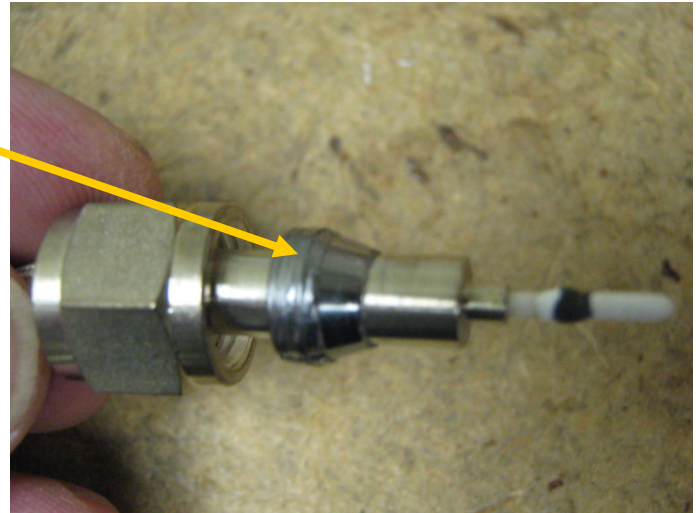
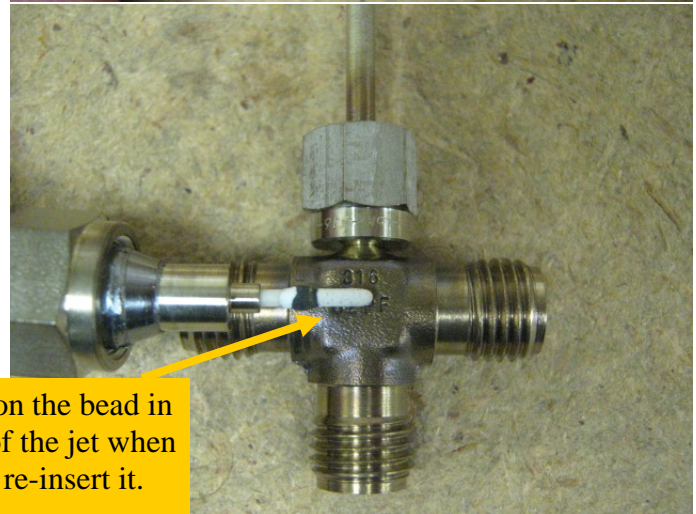
Make sure the collector electrode is not too close to the bead. The end of the collector electrode should just be visible when looking down from the top.

Be sure not to hit the bead with the column. This can happen if the column is inserted too far.

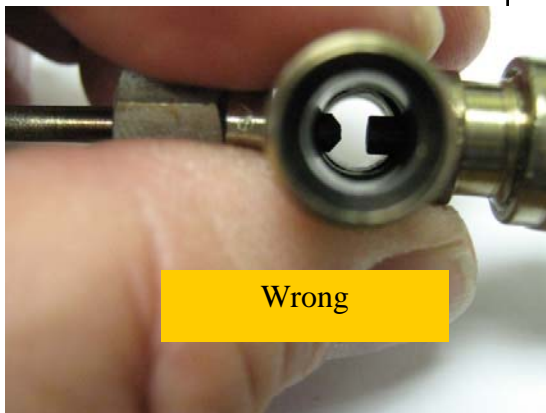
Wrong

Position the bead in front of the jet when you re-insert it.
